Fort Smith Reservoir Intake Tower

The concrete intake tower for a new reservoir at Lake Fort Smith State Park was experiencing leakage at construction joints in the substructure.

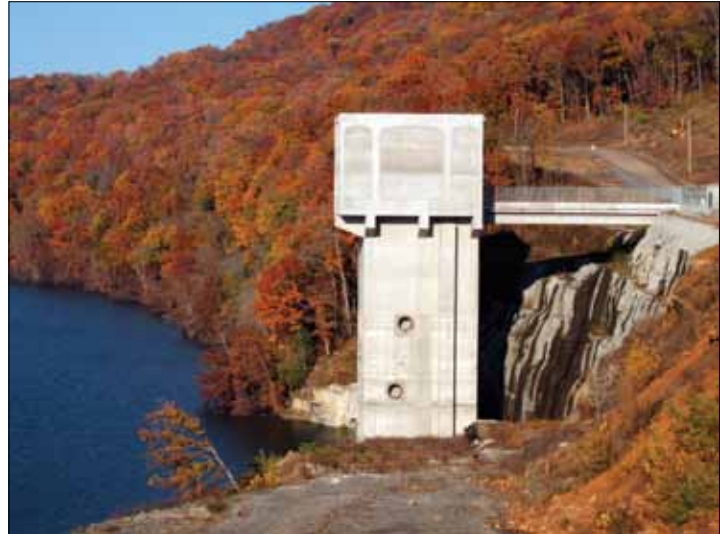
Figure 1 The concrete intake tower at Lake Fort Smith State Park.

As the water reservoir was filled, various leaks were occurring at different elevations, causing dampness and calcite to form inside the access well of the concrete structure.

Even though the substructure where the leaks formed was designed with double waterstops and walls more than 5 feet thick, water was bypassing the waterstops through various shrinkage cracks, including fractures and form tie holes adjacent to the horizontal construction joints.

The concrete walls appeared dry and (any further) water leakage at the construction joints was abated.

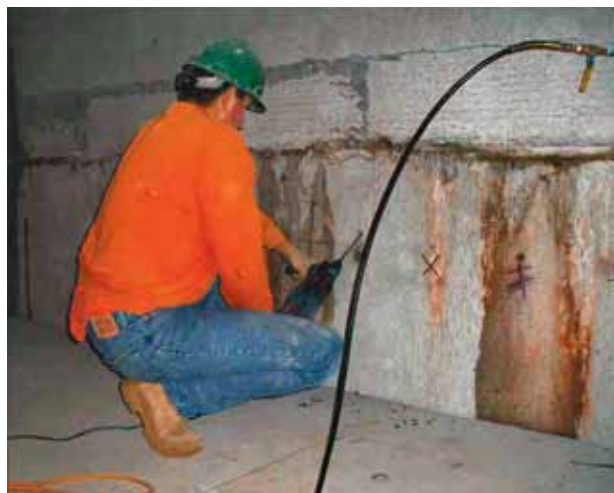
- Holes were drilled 3/8 inches in diameter by 36 inches deep.
- The hole depth was achieved in three stages: 10 inches to 22 inches to 36 inches.

Figure 3 Drilling continues along the construction joint.

- Polyurethane was injected along the horizontal construction joints and principal cracks at a rate of 0.13 gallons per foot.
- Additional polyurethane was injected into the leaking form tie holes to prevent water from traveling through the wall at these locations.
